RESIDENTIAL INSPECTION REPORT

123 Any Street
El Dorado Hills CA 95762

JUNE 15, 2020

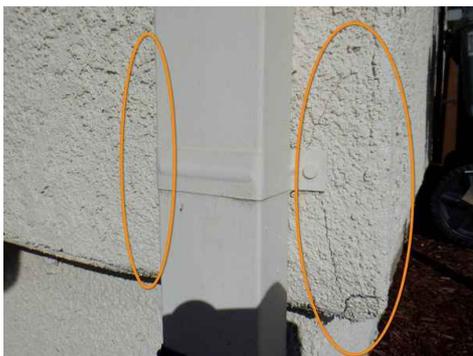
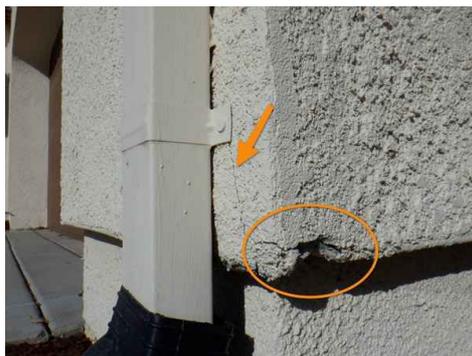
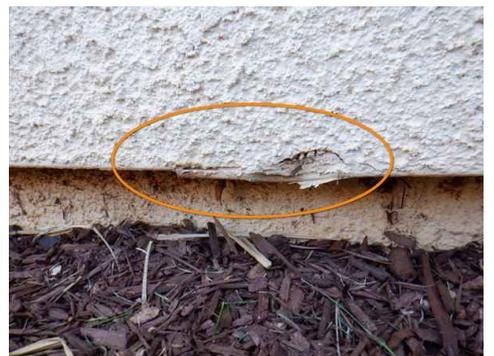
Front Downspout

CRACKING - MINOR

Siding was observed to have minor cracking or other minor damage in one or more places. Some of the cracks were observed at nail holes used to secure the downspouts in place. Other cracks may be a result of temperature changes, and can be typical as homes with stucco age. Recommend repairing any and all missing stucco, sealing all cracks, repainting, and monitoring. If the cracks worsen, then recommend evaluation and repair by a qualified professional.

Recommendation

Contact a stucco repair contractor

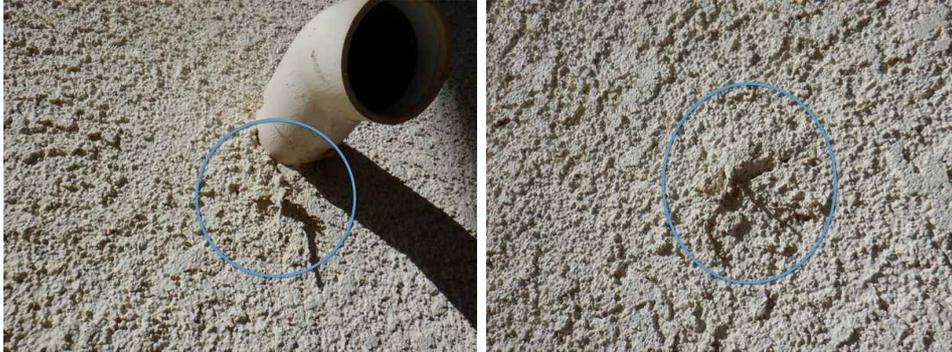
Two Feet Above Garage Occupant Door

Stucco Wire was observed to be protruding from the wall. While no oxidation ("rust") was observed on the wire, if the wire does later oxidize then the rusting metal may expand and cause cracking of the stucco siding and possible stucco deterioration among other problems associated with water damage. Recommend evaluation and repair by a qualified professional.

Recommendation

Contact a stucco repair contractor

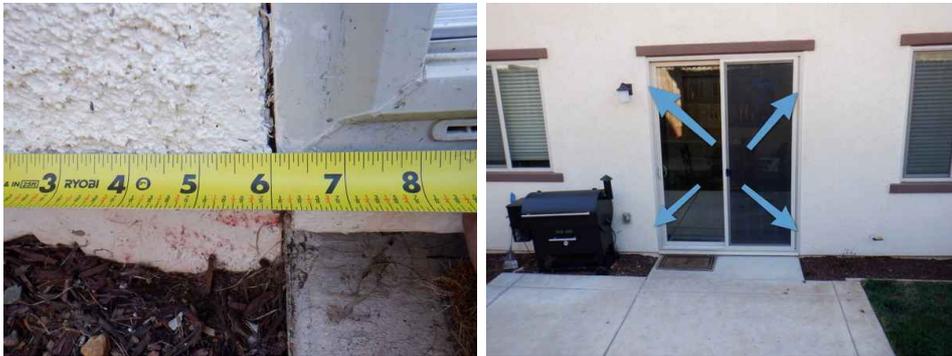
MISSING OR CRACKED CAULKING

Minor cracking or missing caulking was observed. Recommend resealing joint with new caulking and paint.

Recommendation

Contact a handyman or DIY project

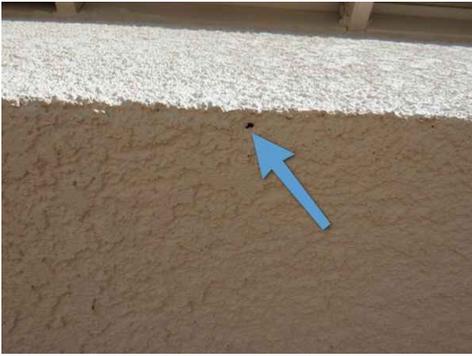
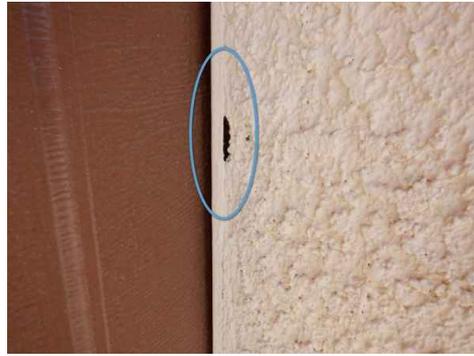
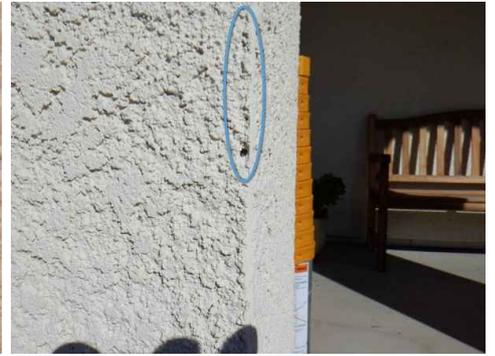
PEROCITY, DIVETTS, OR HOLES

One or more areas had cavities which were missing wall covering material. It is unknown if these cavities extend through the wall covering and may present the opportunity for water to penetrate the wall covering. It is recommended that these cavities be patched or filled because in these areas water may also collect and over time contribute the water damage which may include wood deterioration. The cavities should be monitored, and if they worsen then recommend evaluation and repair by a qualified professional who specializes in Stucco/EIFS.

Right of Garage Door, Under Eaves

Right of Garage Door

Facing Front Porch

Recommendation

Contact a qualified professional.

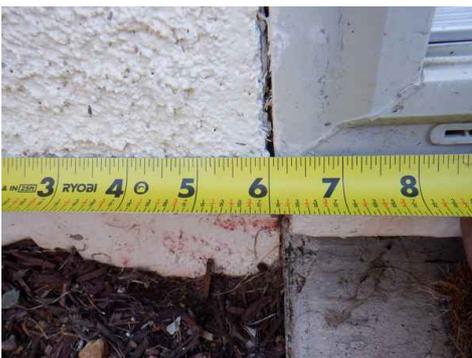
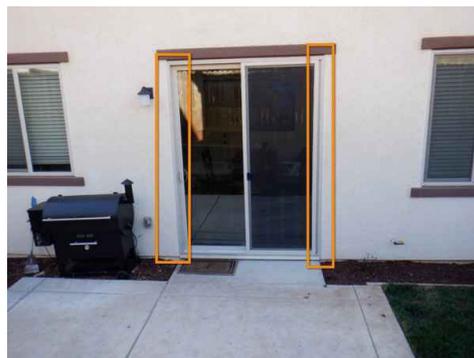
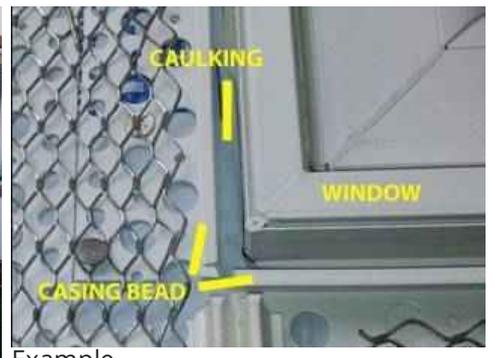
STUCCO - MISSING "CASING BEAD" AT STUCCO TERMINATION

Casing Bead material was not observed at wall penetrations including windows and doors. With some stucco applications the casing bead may not be required if compatible windows and doors are used with flexible caulking.

Rear Sliding Door

If at some time in the future client chooses to upgrade windows and doors, then it is recommended client also consider installing casing bead where the stucco meets these dissimilar materials, and apply caulking to the joints.

Recommendation

Contact a stucco repair contractor

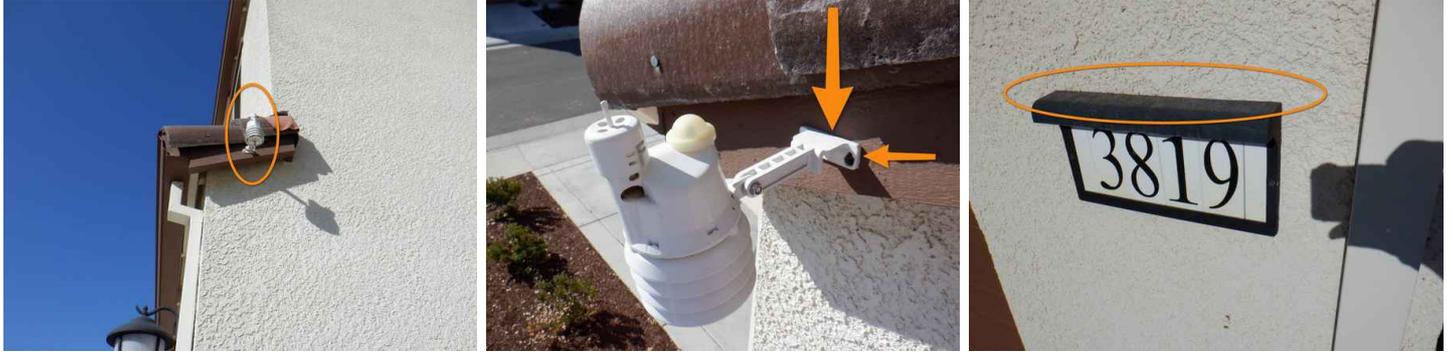
Whenever equipment is attached to siding or trim, applying a flexible and non-shrinking sealant ("caulking") is prudent and necessary to prevent any water intrusion and subsequent deterioration of the siding or trim. Recommend evaluation and application of a sealant by a qualified professional.

Recommendation

Contact a handyman or DIY project

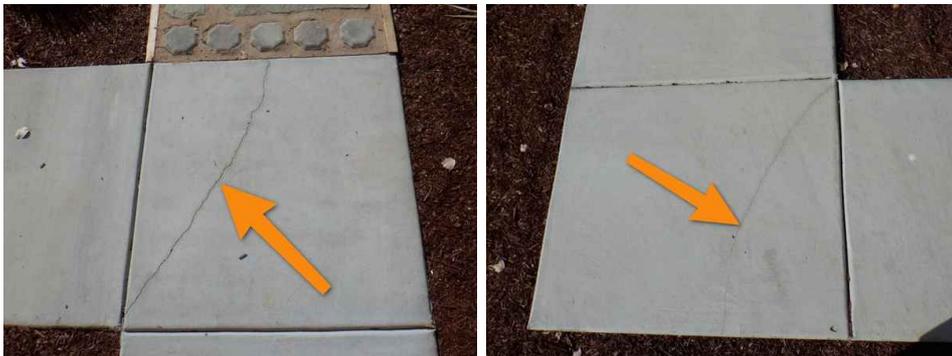
WALKWAY CRACKING - MINOR

Minor cosmetic cracks observed. Recommend monitor and/or patch/seal.

North Front

South Front

Recommendation

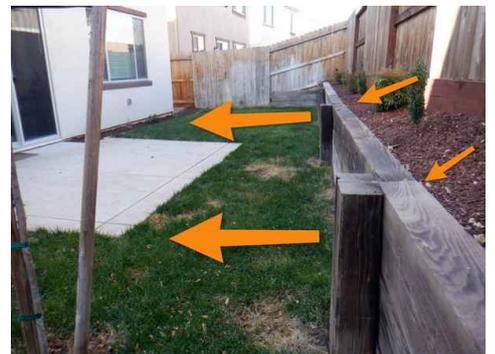
Grading is sloping towards the home in some areas. This could lead to water intrusion and foundation issues. Recommend qualified landscaper or foundation contractor regrade so water flows away from home.

Recommendation

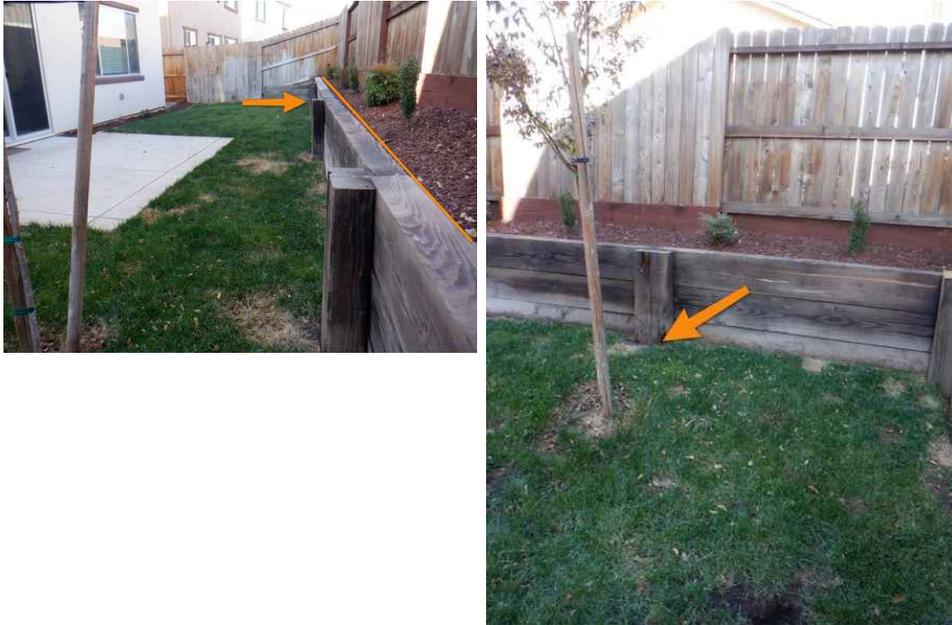
Wood Deterioration

**RETAINING WALL CRACKS**

A retaining wall is present. While the retaining wall was observed to have deviations, indications of structural failure or lateral movement were not observed. **Evidence of wood deterioration was observed** at one or more pile-on support beams. Recommend evaluation and repair by a qualified professional.

Recommendation

Contact a qualified landscaping contractor

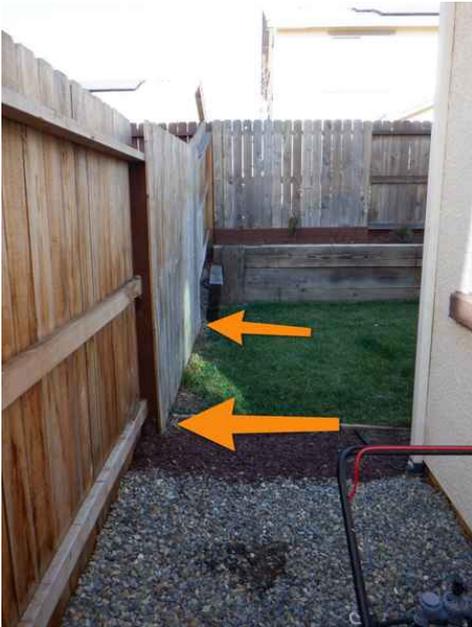
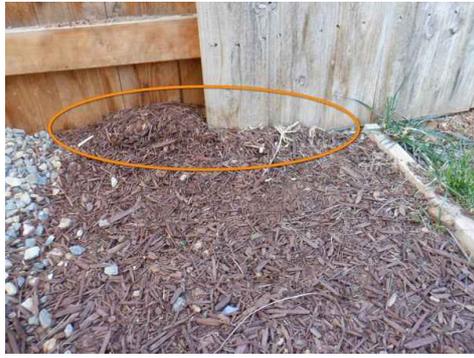
**DIRT OR LANDSCAPING MATERIAL MAY DETERIORATE FENCING**

One or more areas of "wood to earth" contact was noted along the fencing. This can cause excessive moisture and wood deterioration, prematurely shortening the intended service life of the fencing.

Recommend removing landscaping debris and unnecessary dirt build-up from posts and other fencing components.

Recommendation

Contact a handyman or DIY project

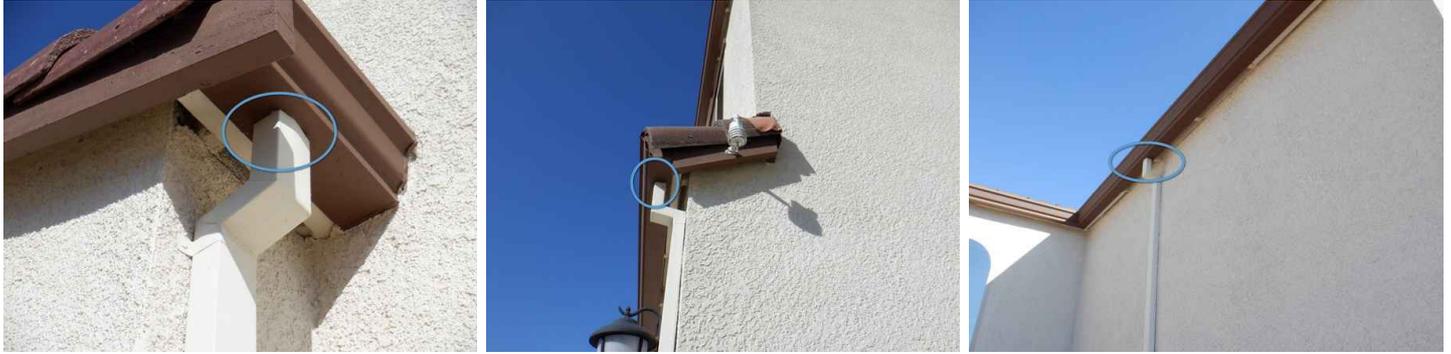
One or more downspout(s) were not properly attached to the gutter. This may contribute to a downspout becoming loose or leaking at the connection with the gutter. Recommend evaluation and repair by a qualified professional.

Recommendation

Contact a qualified gutter contractor

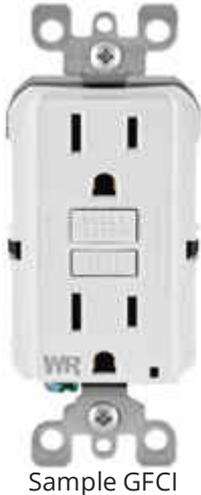
Sample GFCI

GFCI outlets are important, especially when the electrical outlets are positioned close to water. Installing GFCI outlets in your kitchen, bathrooms, laundry rooms, exterior, garage, pool house etc., is a great idea.

If in any of these areas there are non-GFCI protected electrical receptacles ("outlets") installed, then as a recommended upgrade client is encouraged to have GFCI protected outlets installed.

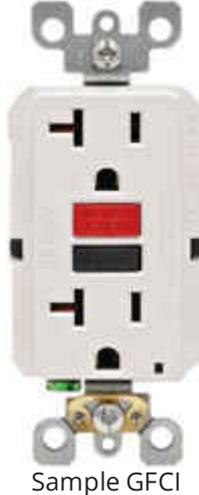
Sample GFCI

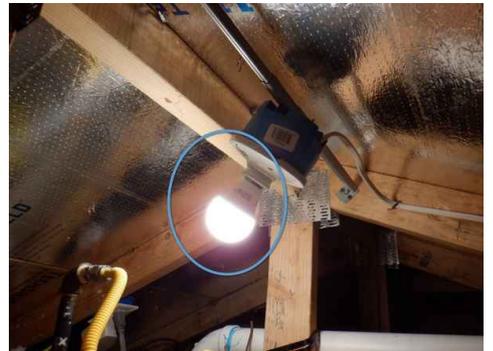
One or more light bulb(s) located in areas which are readily accessible to persons was observed to be unprotected. In that light bulbs are fragile and get hot, unprotected light bulbs create a risk of personal injury by the potential for broken glass or extremely hot surface area if the bulb is broken or touched. A glass globe or cage assembly may be appropriate to protect the bulb(s). Recommend evaluation and repair by a qualified professional.

Recommendation

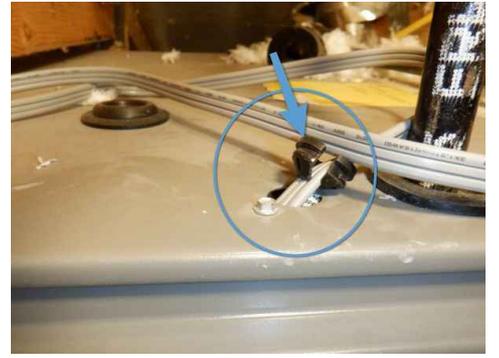
UNPROTECTED WIRES

One or more electrical connections had electrical wiring ("conductors") passing through a metal cabinet without adequate protection. This could result in deterioration of the sheathing around the electrical wires, and possible fire or electrocution. Recommend evaluation by a qualified professional.

Recommendation

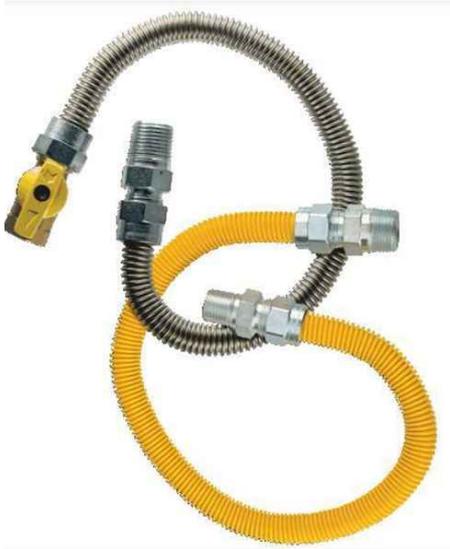
Example of Modern FAC

A Flexible Appliance Connector (FAC) was observed to be used to connect rigid gas supply pipe to one or more gas appliance(s). This is not uncommon and is not a deficiency. Suitable applications of FAC vary based upon manufacturer's specifications. FAC are thin-walled metal and do not provide the same protection as traditional steel piping. FAC also do not protect against lightning strikes which do occur in this region, and are rarely equipped with protective electrical bonding with the gas supply line piping. Pipe doping / thread sealant materials may interfere with electrical bonding continuity and reliability.

Increased care should be observed when handling or installing FAC. FAC should not be kinked or excessively bent, as the thin walls may form a break which allows combustible gas to escape and create a fire hazard. If there is any indication of damage or corrosion seen on the FAC, then the FAC should be replaced by a qualified professional. FAC generally should not be used outside or be exposed to the natural elements, unless explicitly permitted by manufacturer's specifications.

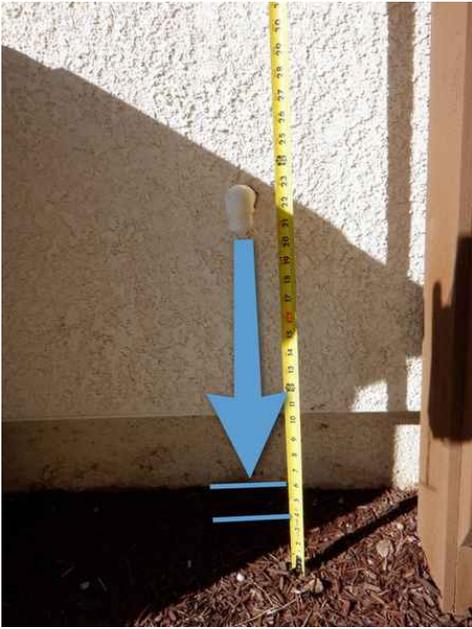
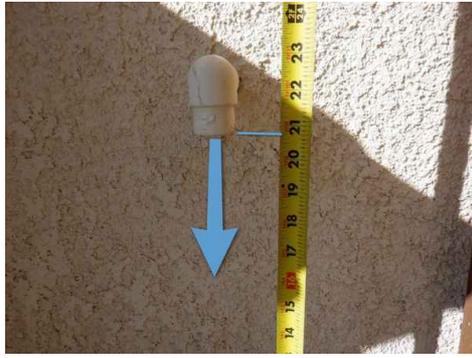
The outlet of the rigid piping connected to the TPR valve is required to be no higher than six (6) inches from the ground surface area. In the event the TPR valve releases hot water from the hot water heater, having the rigid piping outlet no higher than six (6) inches reduces the chances of scalding injuries. It is recommended the outlet be extended at the outside of the structure.

Recommend evaluation and repair by a qualified professional.

Recommendation

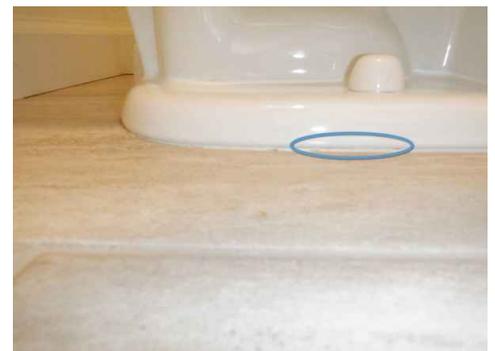
CRACKED CAULKING OR GROUTING

The hallway bathroom toilet was observed to have cracked or missing caulking. This caulking is important to prevent water intrusion under the base of the toilet, and to prevent water damage including but not limited to wood deterioration. Recommend evaluation and repair by a qualified professional.

Note: caulking was present, but had minor cracking, and appeared to be insufficiently applied during installation.

Recommendation

Contact a handyman or DIY project

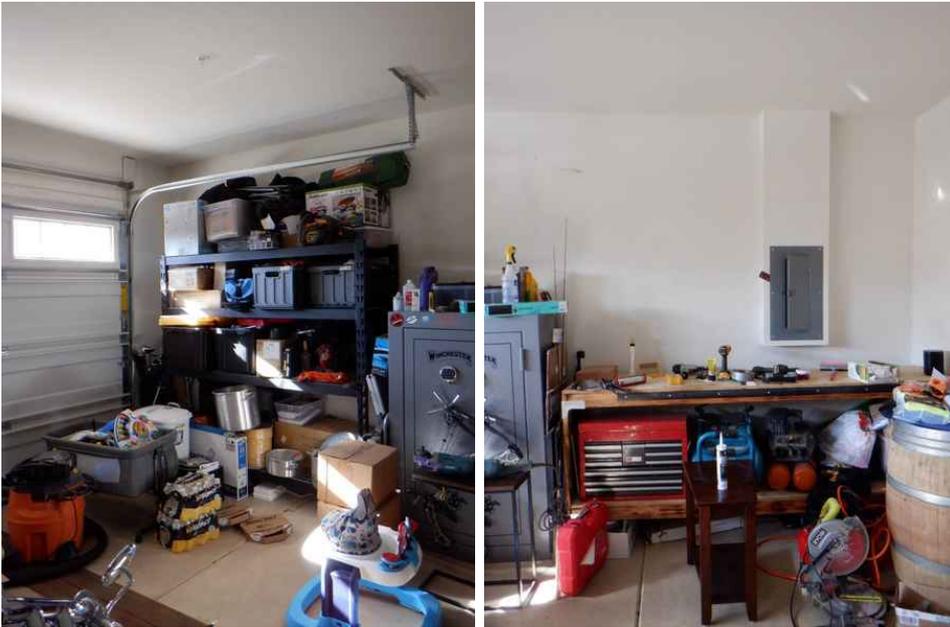
Full visual inspection of garage area was limited by occupants' personal belongings. Visual inspection proceeded in the areas of the garage which were accessible and visible. Prior to the close of escrow (COE) it is recommended occupants' personal belongings be moved or removed so as to allow a full inspection of the garage.

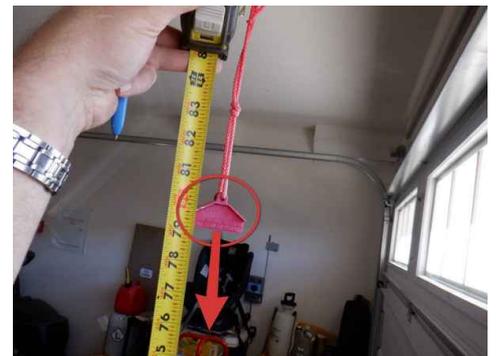
10.5.1 Garage Vehicle Door

In the event of a power failure the garage door may not function and it may become necessary to use the "safety knob" (red handle hanging from the track), to disengage the trolley from the garage door operator's track so that the garage door may be manually lifted up and opened. This red knob is too high, and should be relocated to a height no greater than six (6) feet above the garage floor.

Recommendation

Contact a handyman or DIY project
